# **CASTING BASIN GATE MAINTENTANCE RECORDS**

CYCLE 6

# Kiewit-General Inspection Report

**PROJECT:** SR 520 PONTOONS

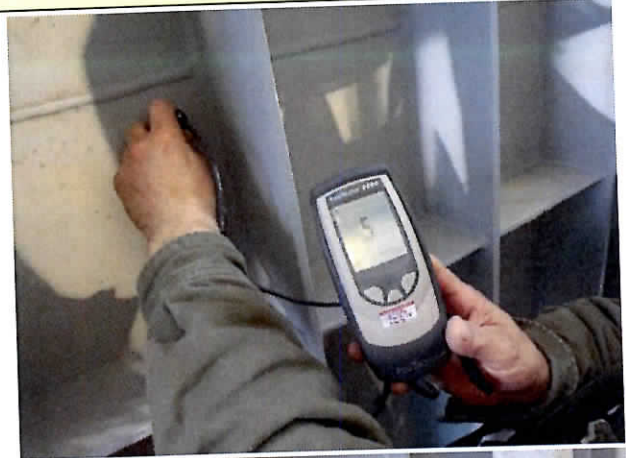
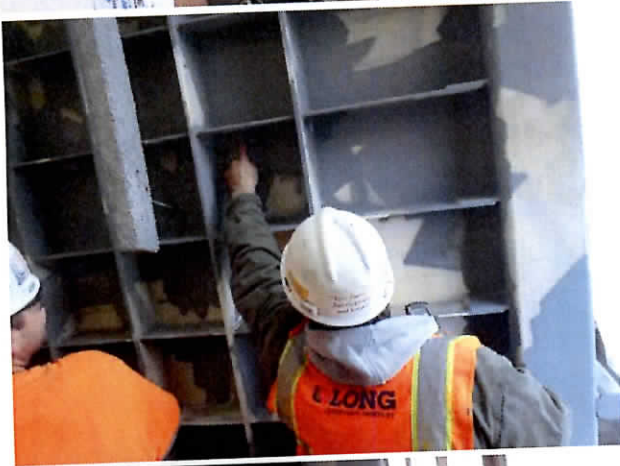
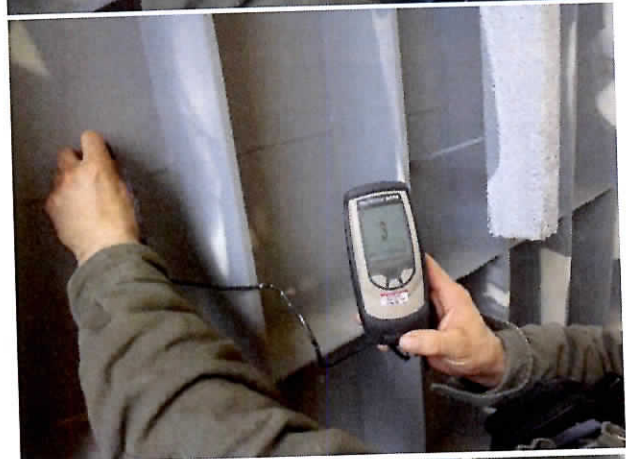
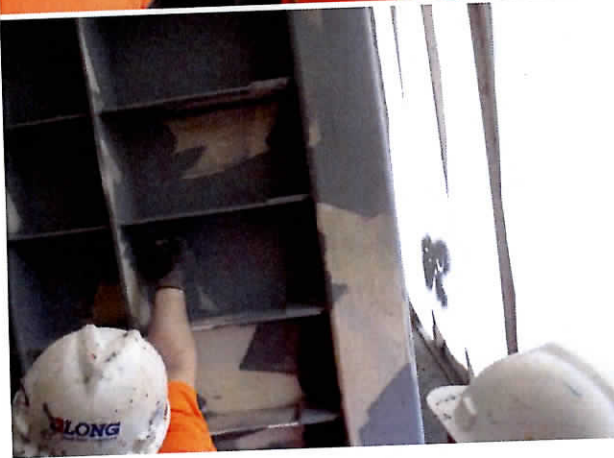
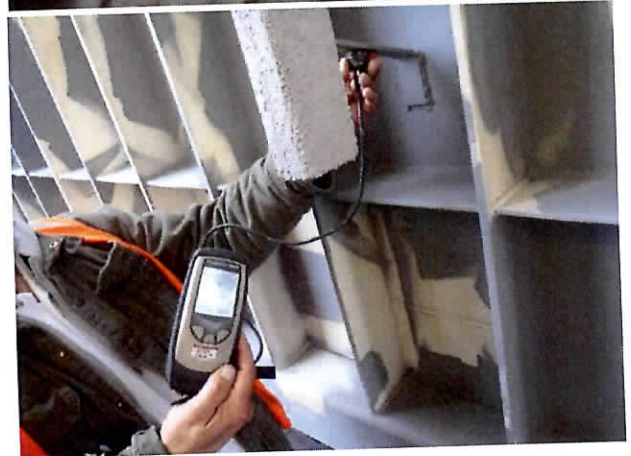
TOP SIX: DFT readings for Zinc primer of T1

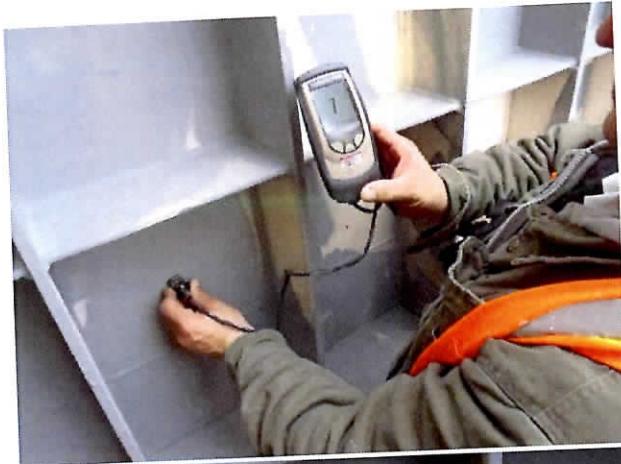
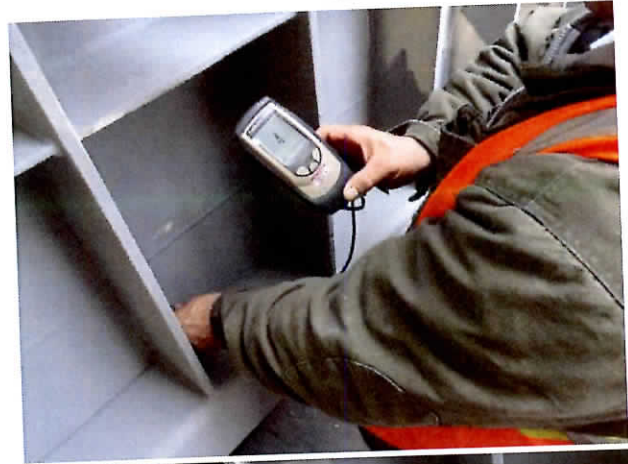
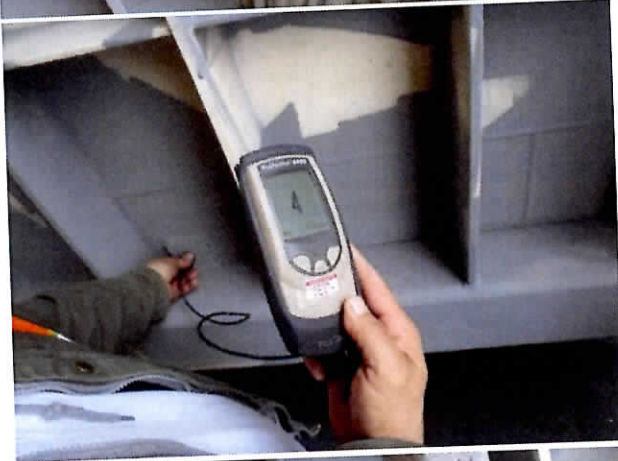
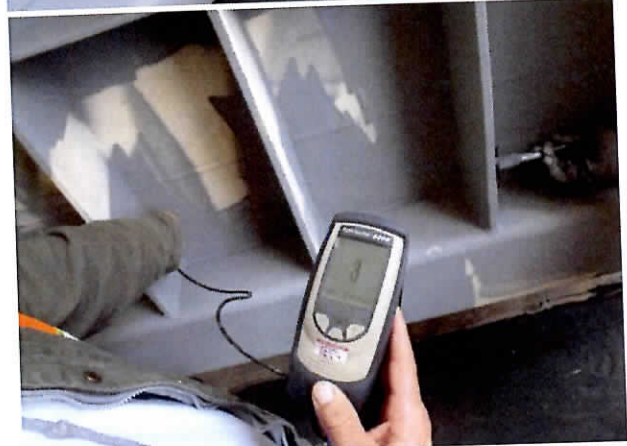
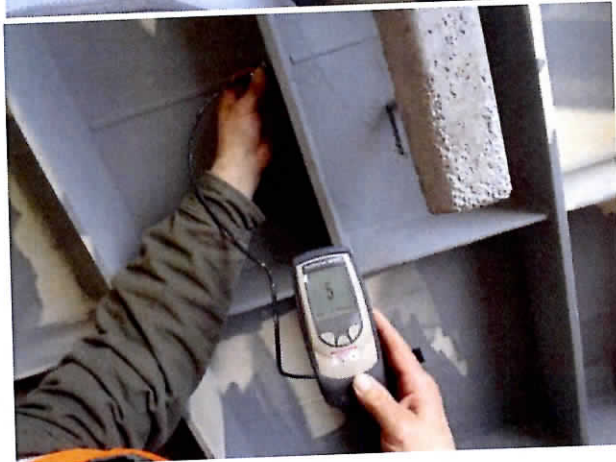
TOP SIX: DFT readings for Zinc primer of T1

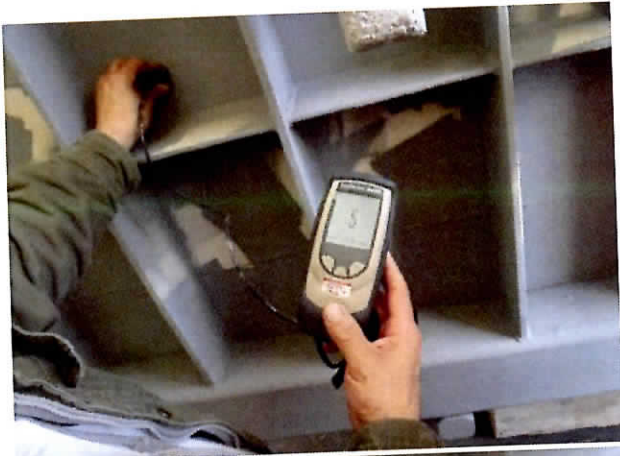
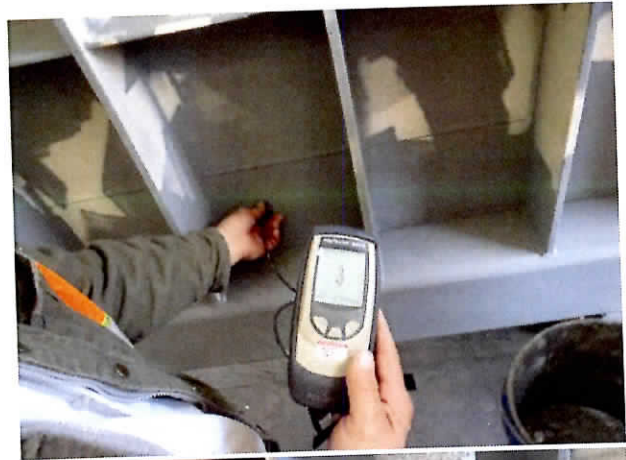
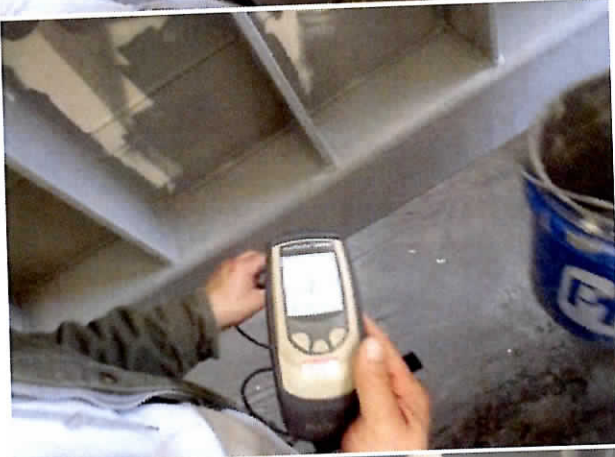
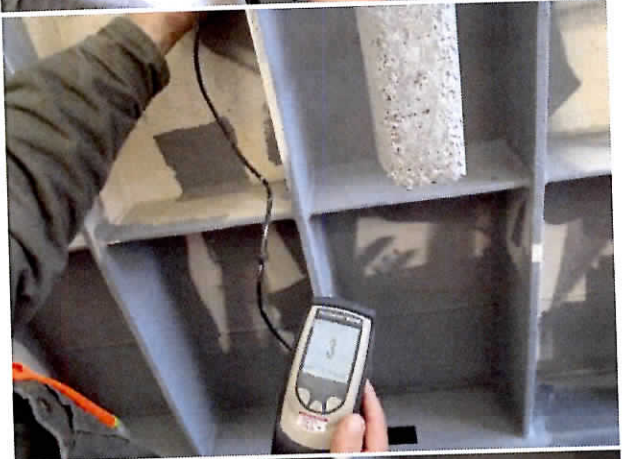
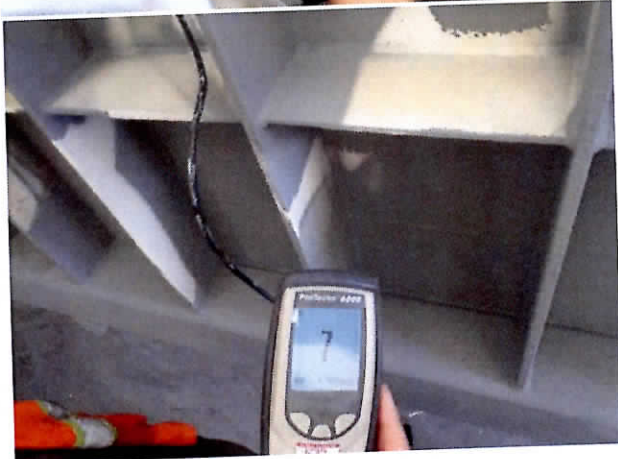
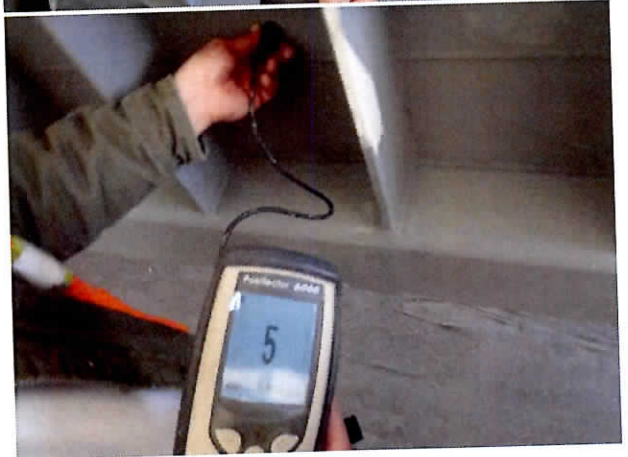
TOP SIX: DFT readings for Zinc primer of T1

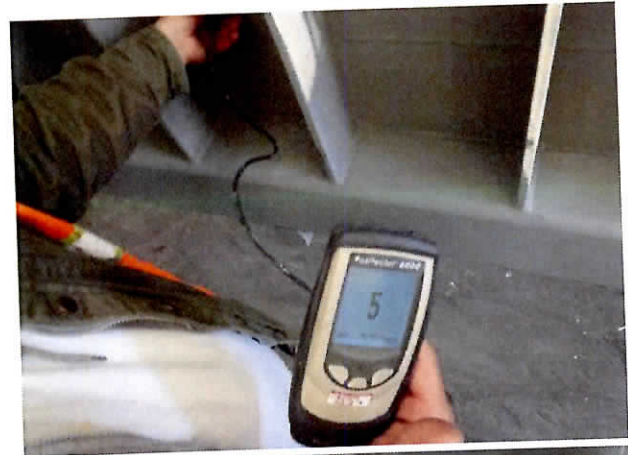
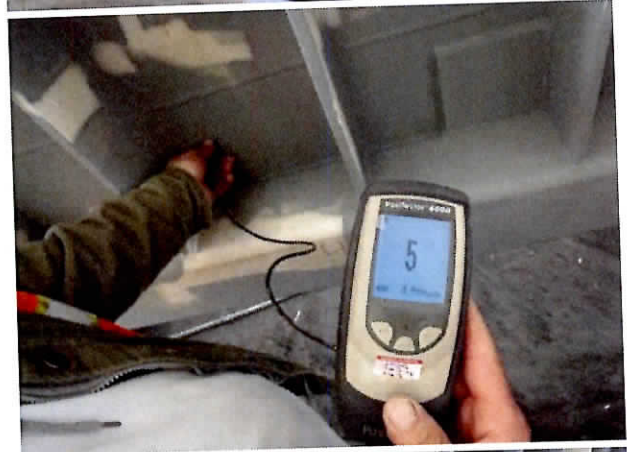
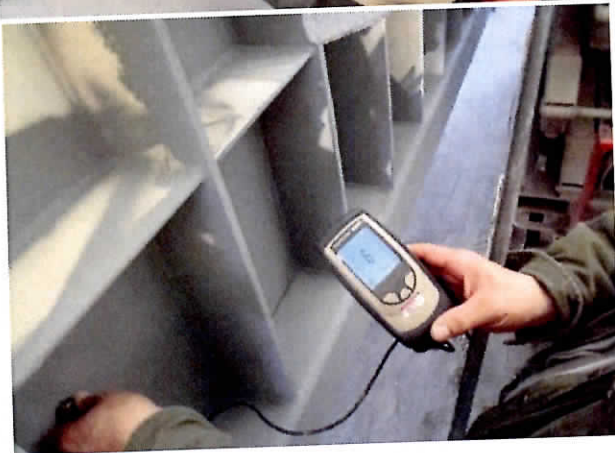
TOP SIX: DFT readings for Zinc primer of T1

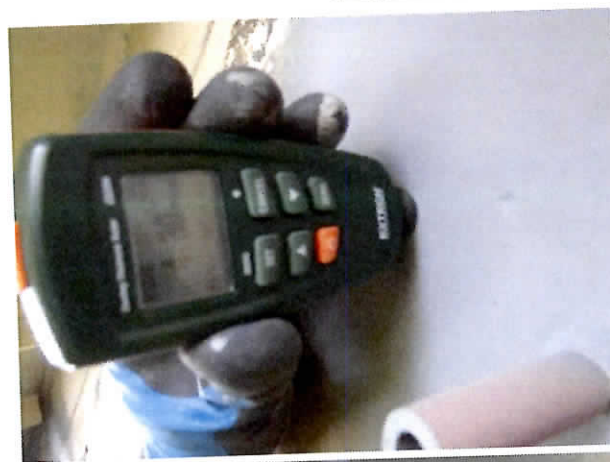
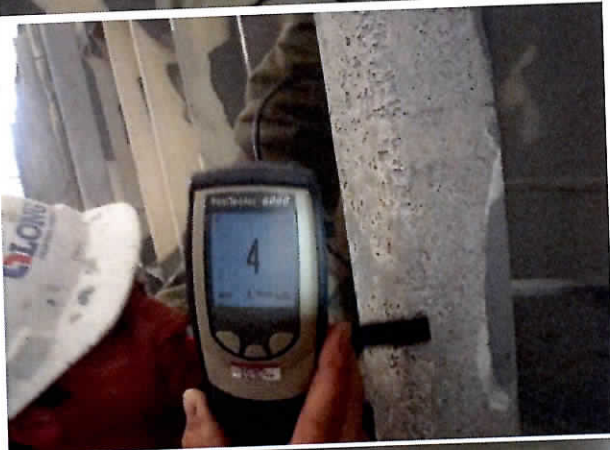
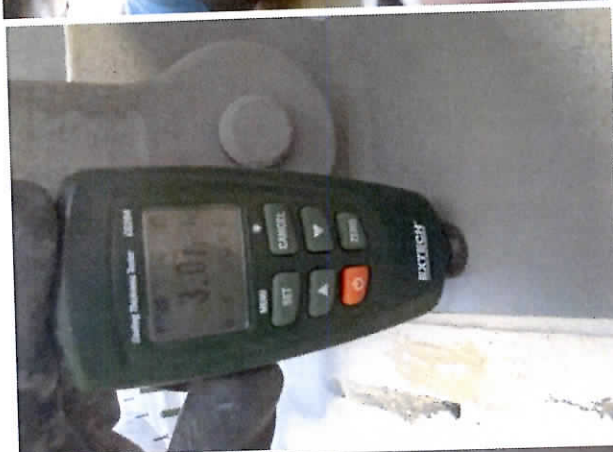
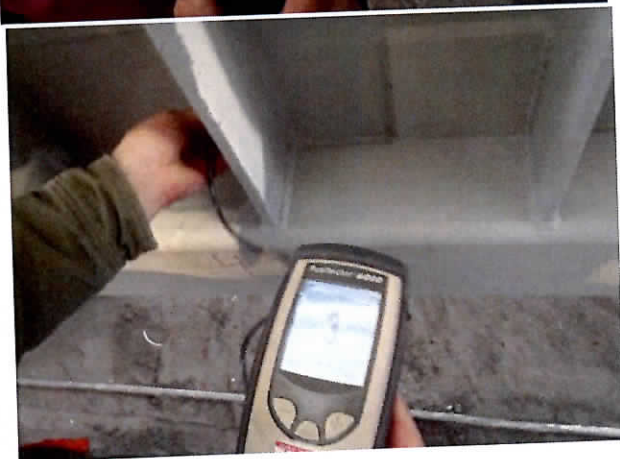
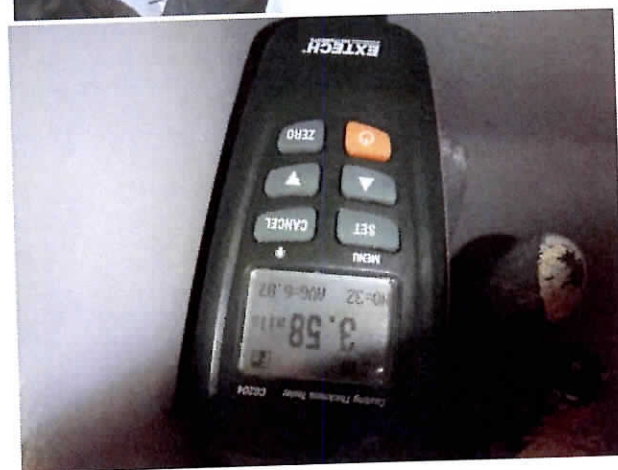
TOP SIX: DFT readings for Zinc primer of T1

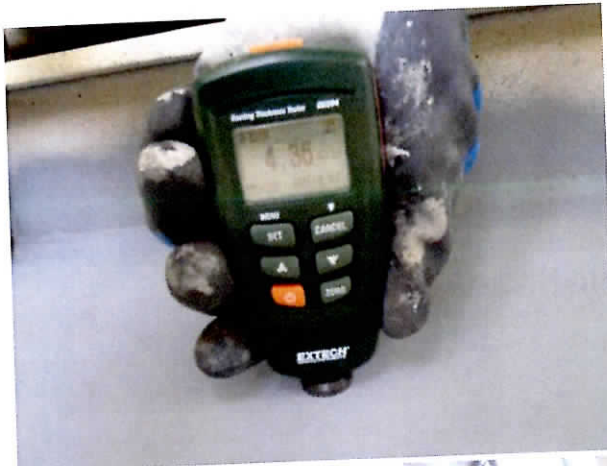
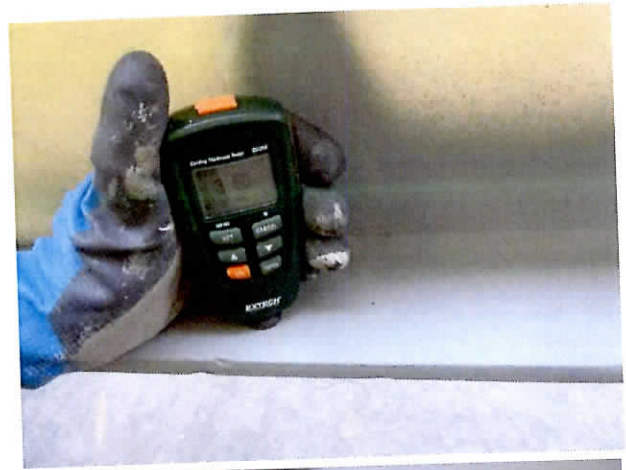
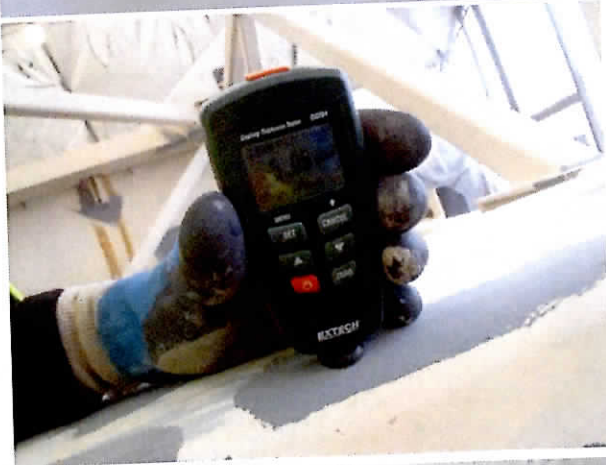
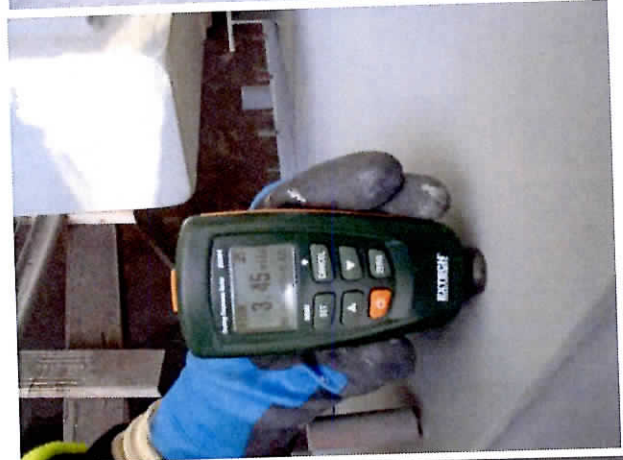
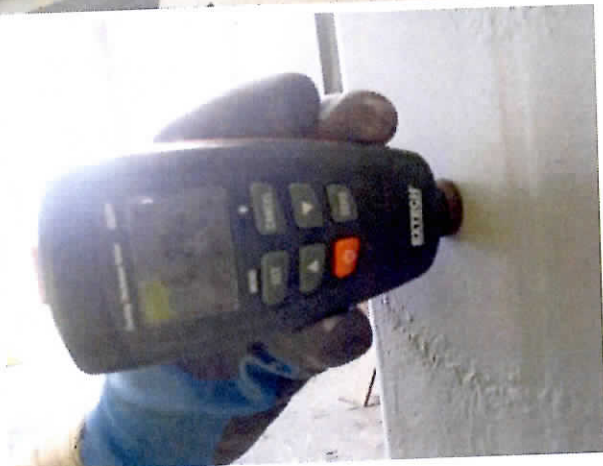
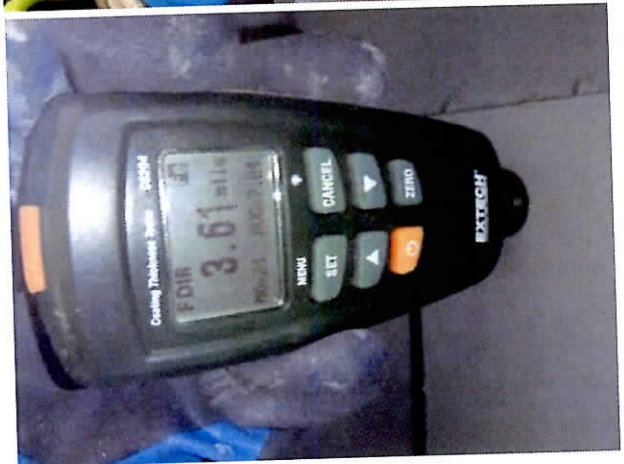
TOP SIX: DFT readings for Zinc primer of T1 (QC tests to left, QA tests to right)

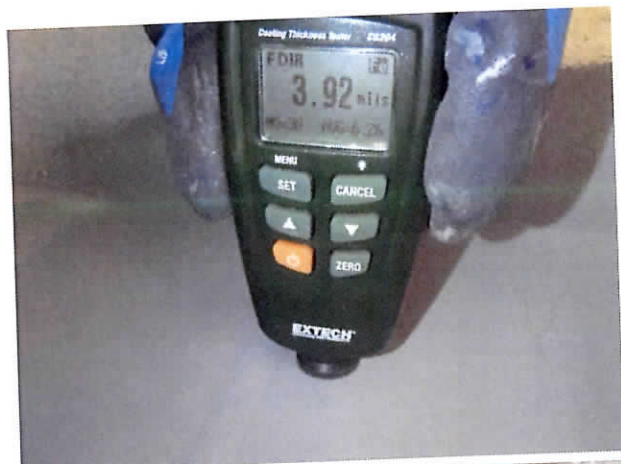
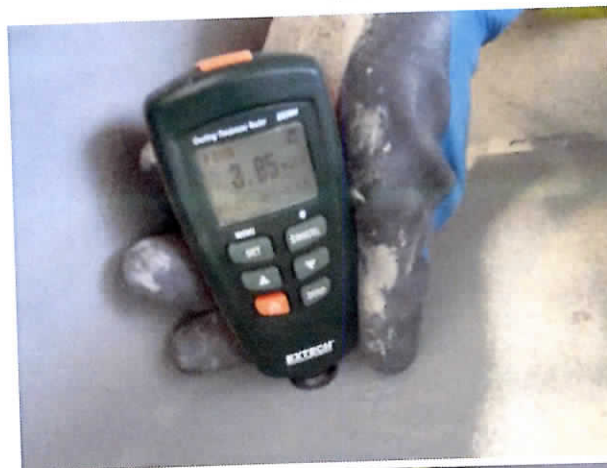
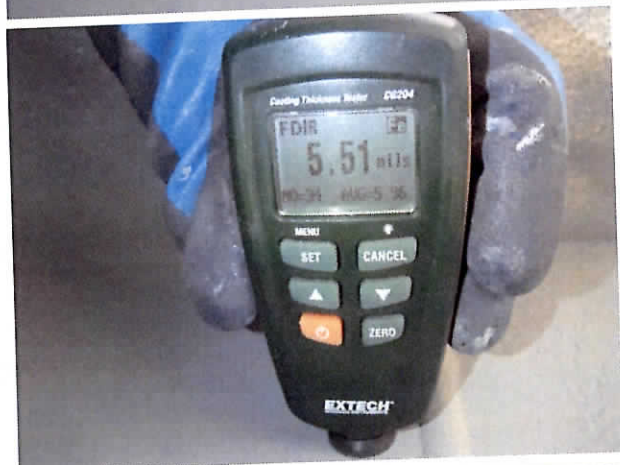
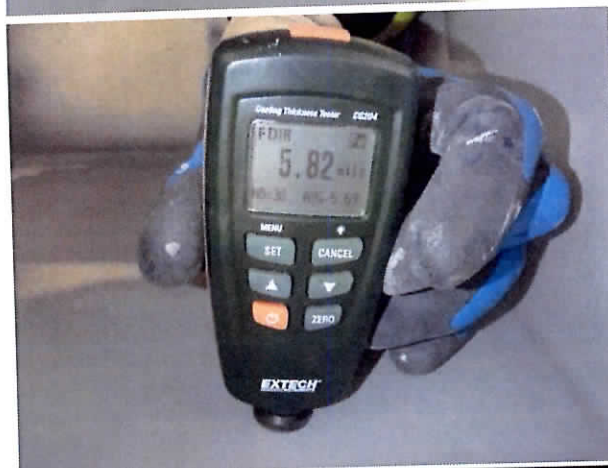
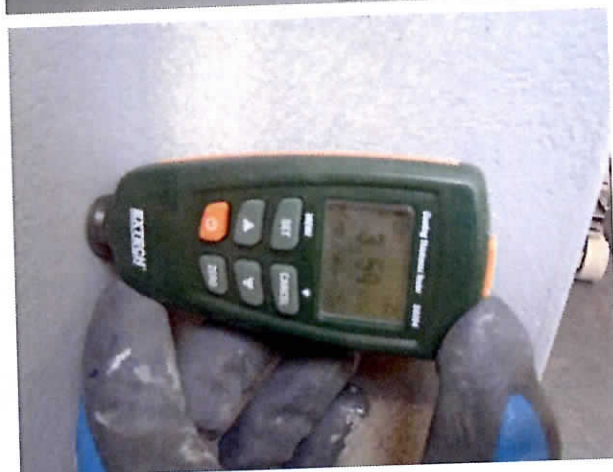
TOP SIX: DFT readings for Zinc primer of T1

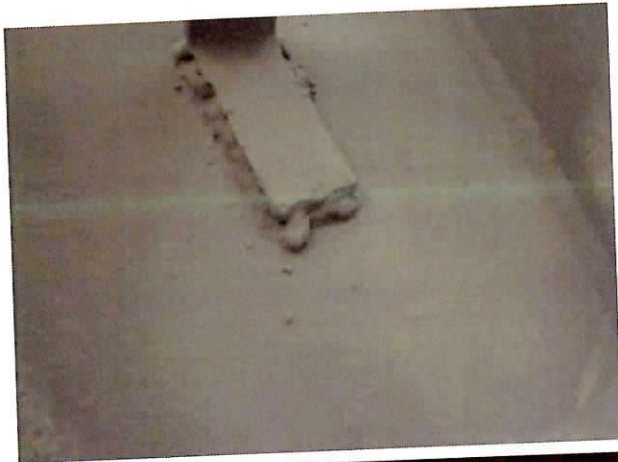
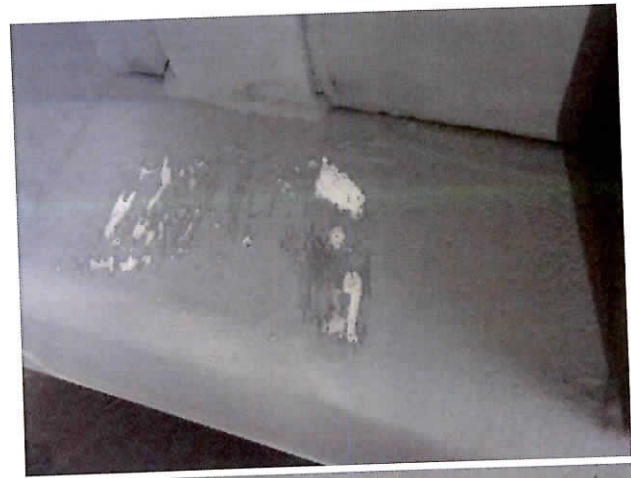
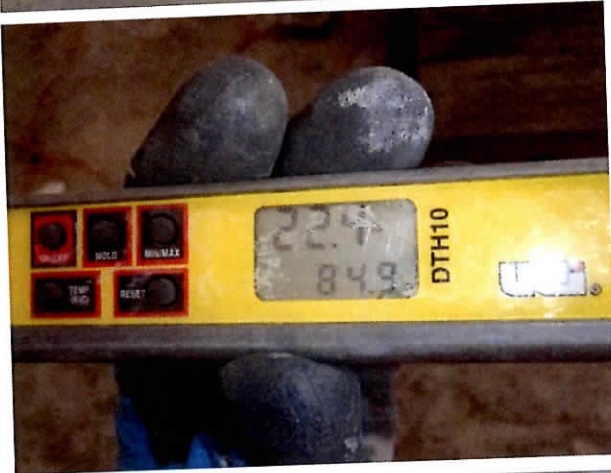
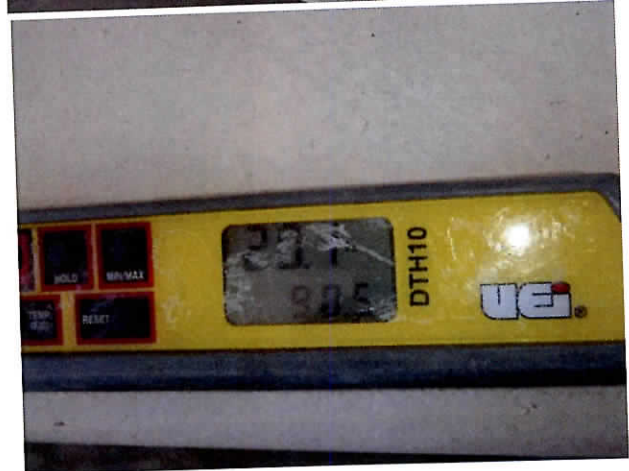
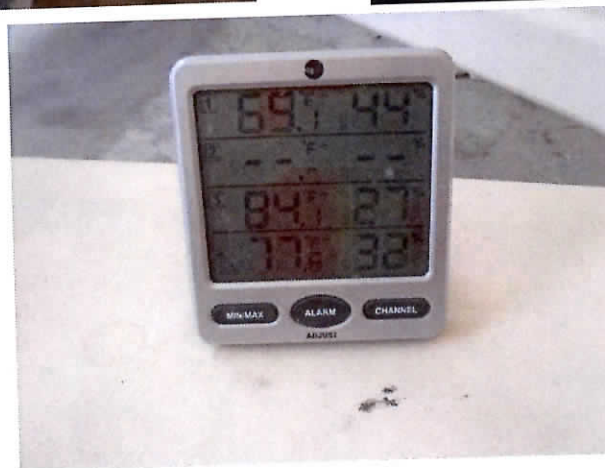
TOP SIX: DFT readings for Zinc primer of T1, Dura-plate 235 used for T2 and T3 touch ups

TOP FIVE: Primer defects to be fixed on T1, atmospheric conditions in tent housing T2 and T3 (middle two), atmospheric conditions in tent housing T1

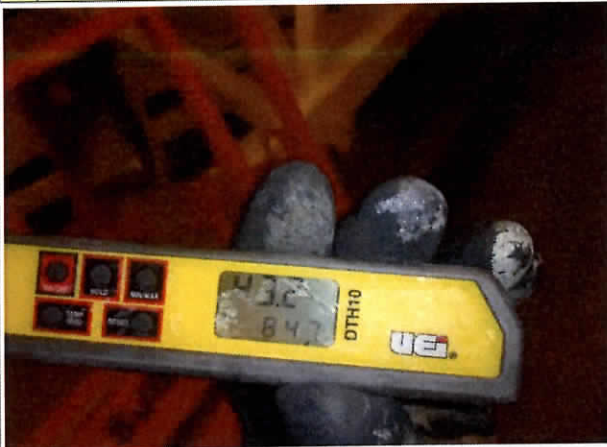
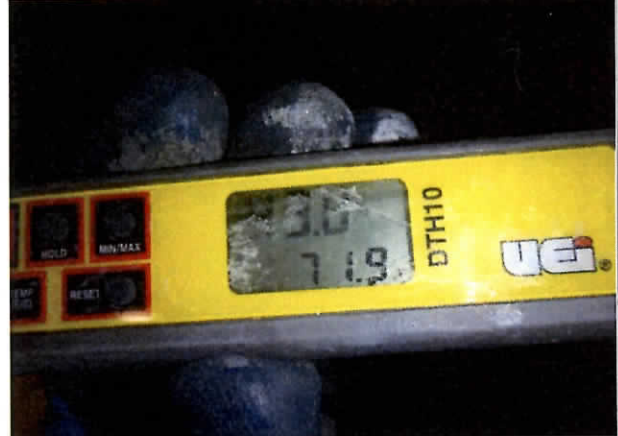
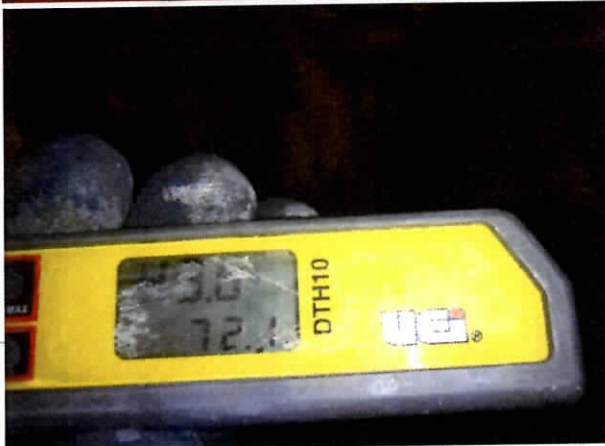
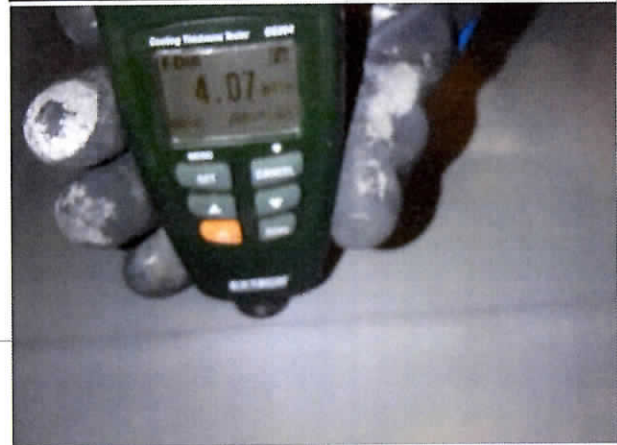
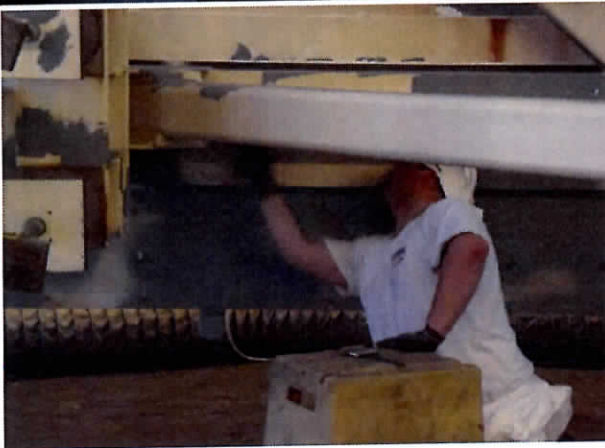
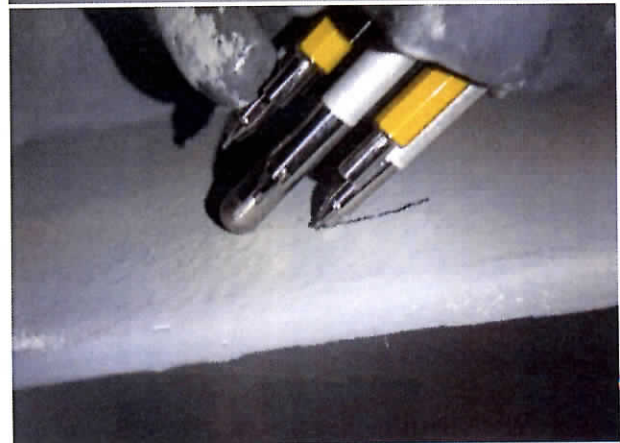
TOP SIX: Atmospheric conditions for coating T1, DFT and anchor profile testing for application of intermediate coat of Dura-Plate to T1, application

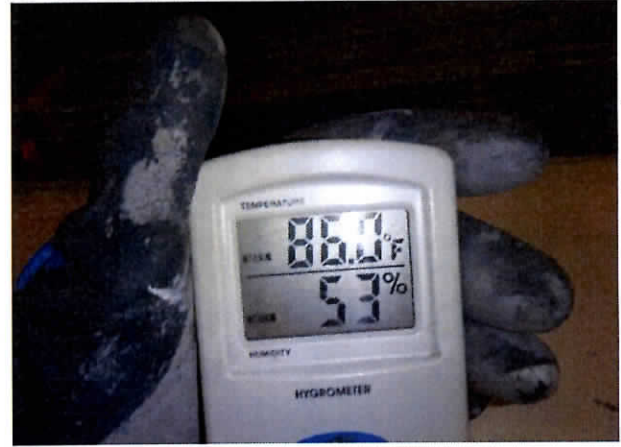
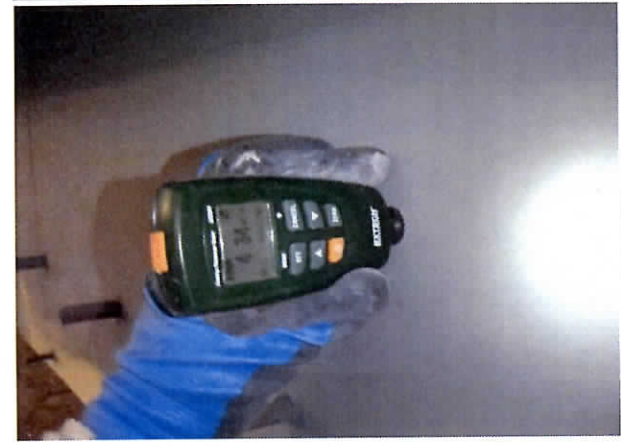
TOP SIX: Stripe coat for T1, pencil hardness and DFT tests upon primer of T1, atmospheric conditions for curing for Trusses 2 and 3

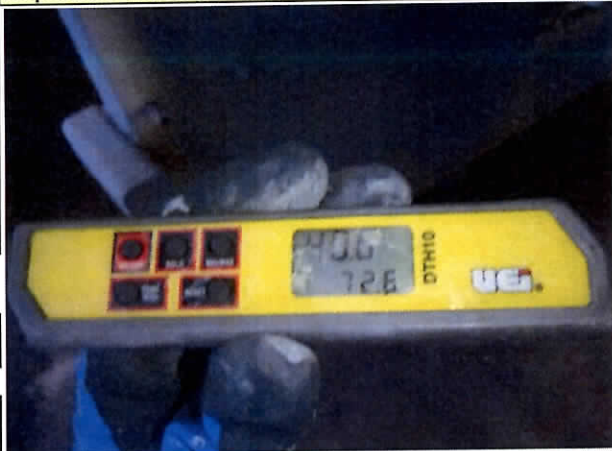
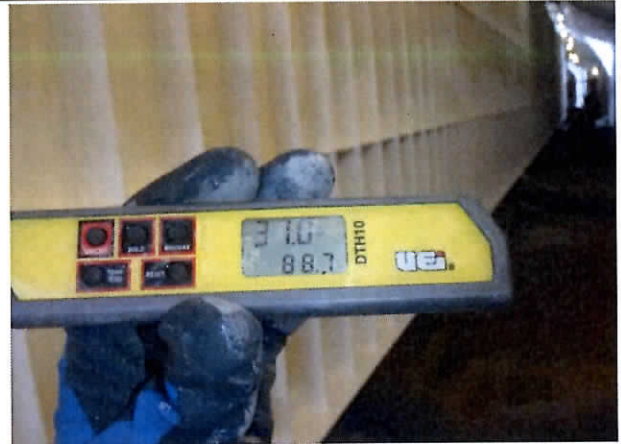
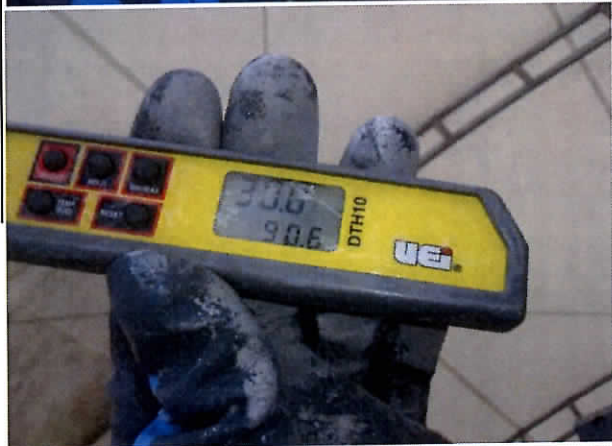
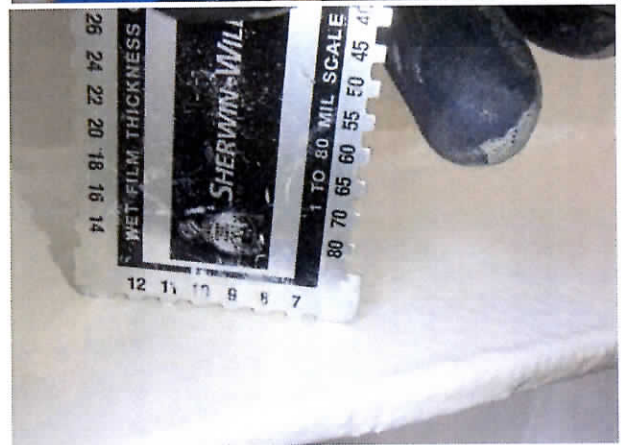
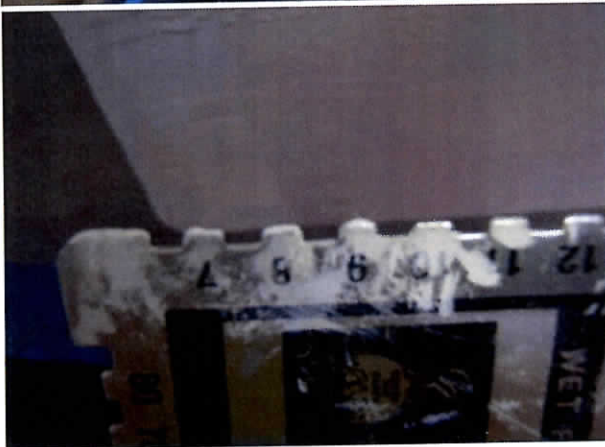
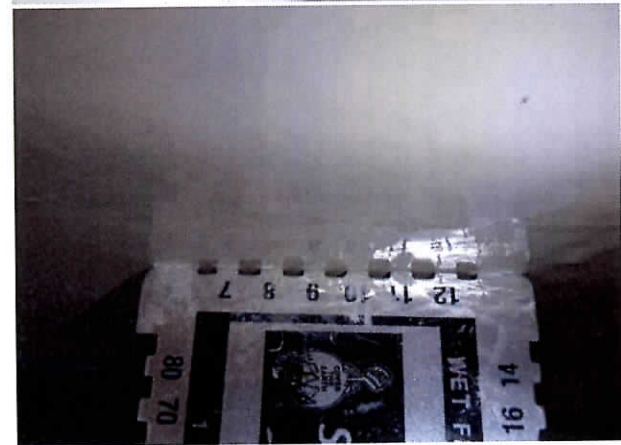
TOP SIX: Intermediate coat and WFT testing Truss 1, atmospheric conditions in Trusses 2 and 3

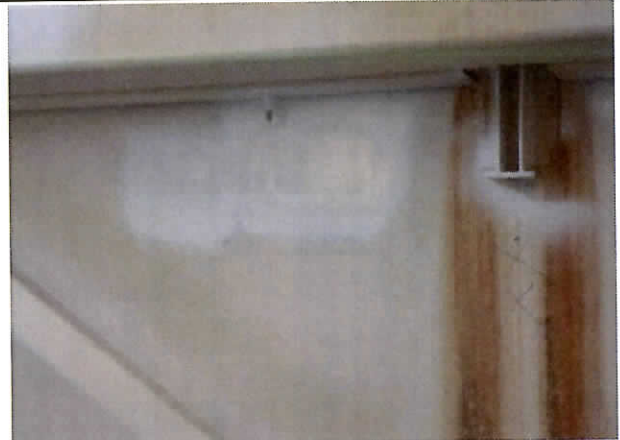
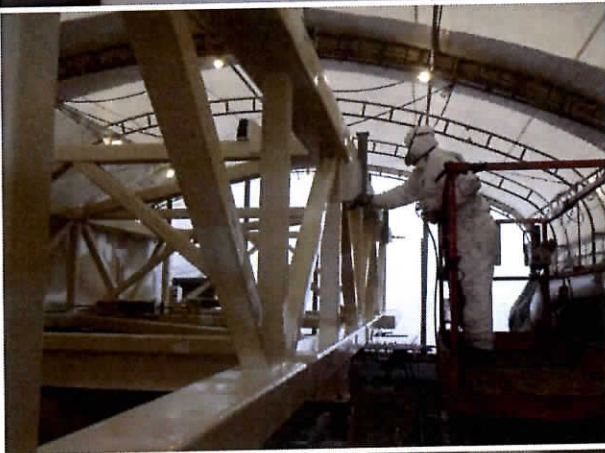
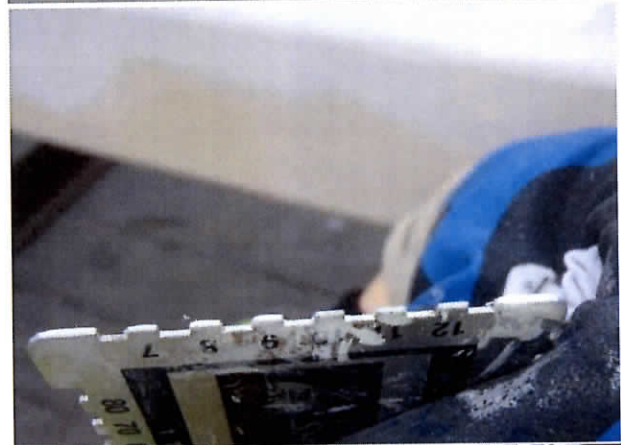
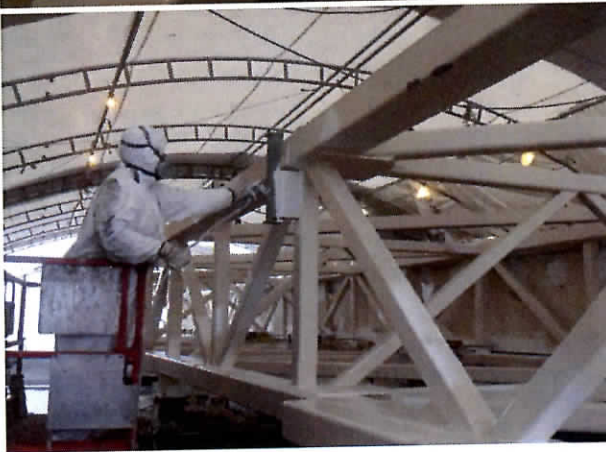
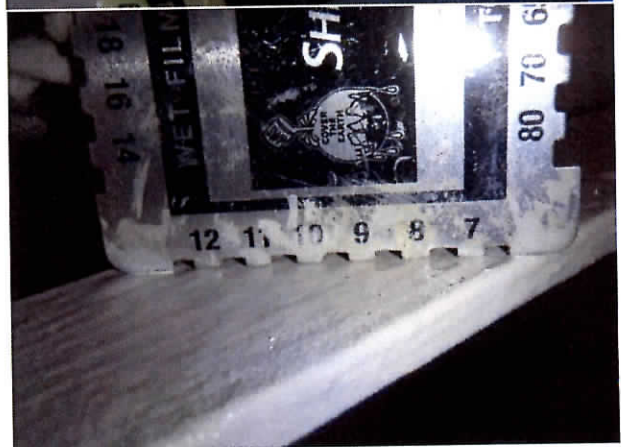
TOP SIX: Intermediate coat, WFT testing Truss 1, atmospheric conditions in Trusses 2 and 3

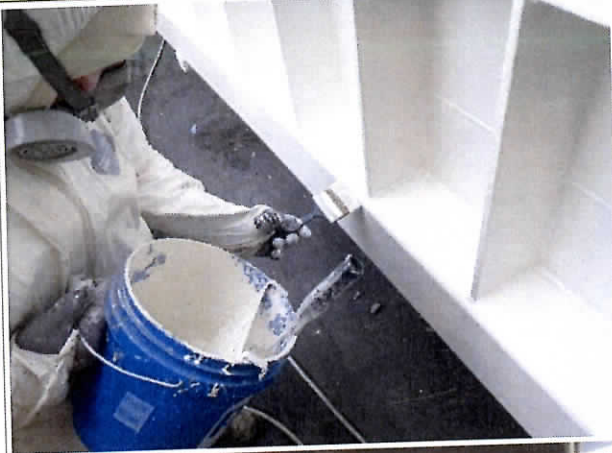
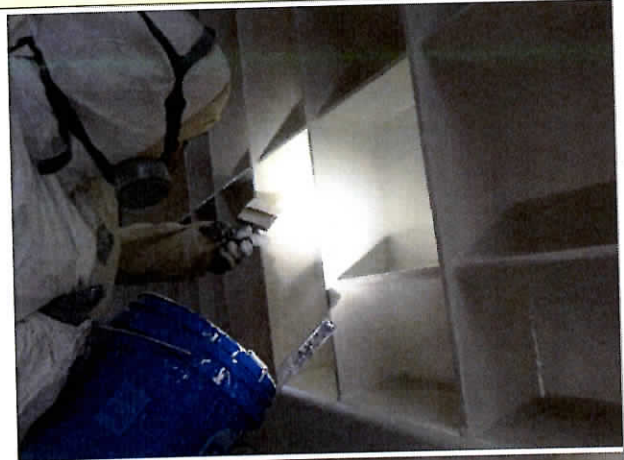
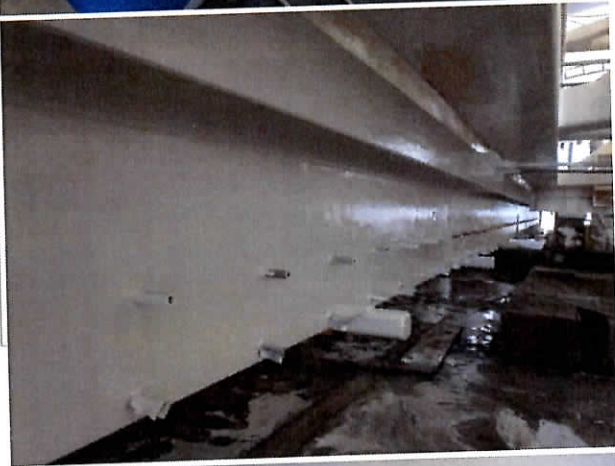
IDR Sheet	QA Key Personnel Function	Date
Sheet 3 of 4	Structural Inspector	Saturday, March 21, 2015
Inspector	IDR Report #	
Doug Brinius	3/21/2015 DB	
Inspector's Notes

TOP SIX: Top coat of Dura-plate 235, WFT readings

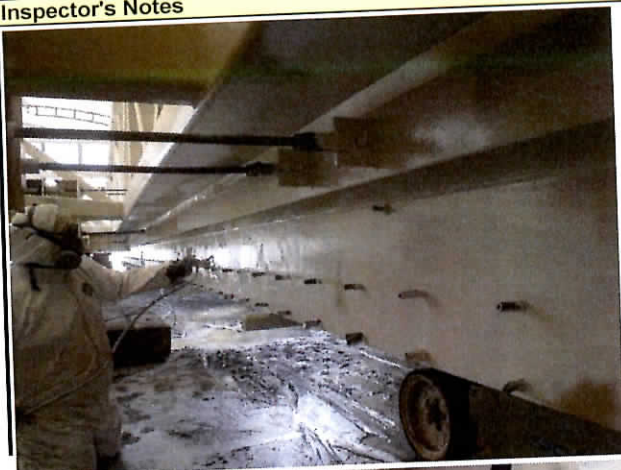
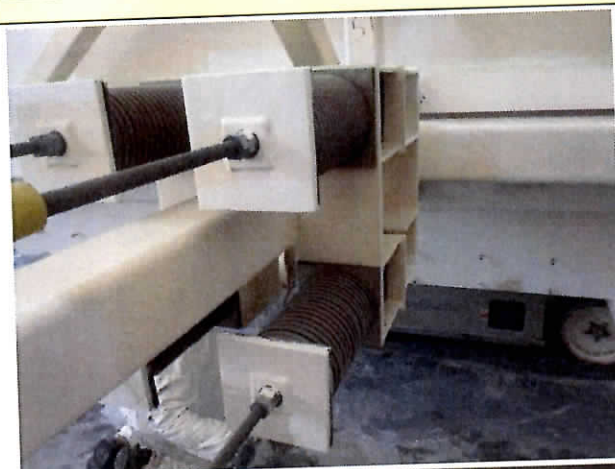
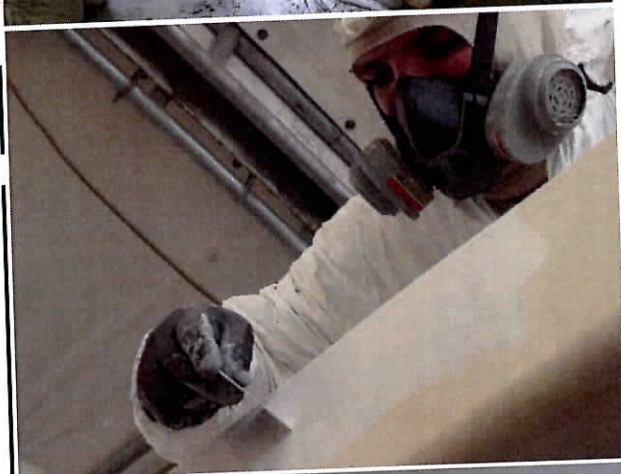
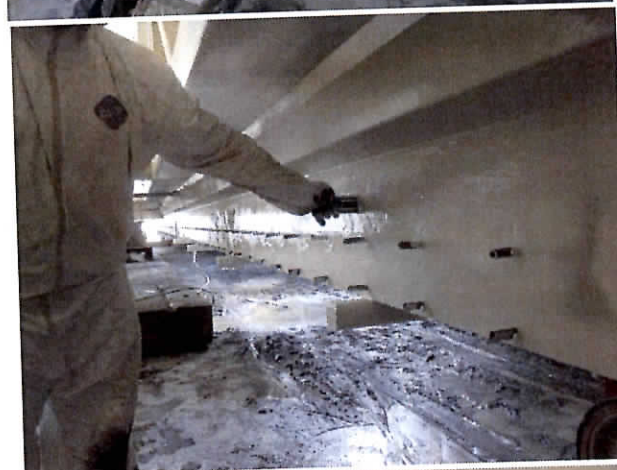
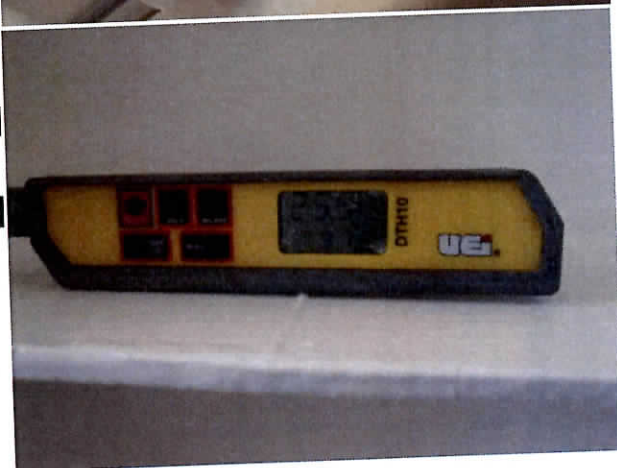
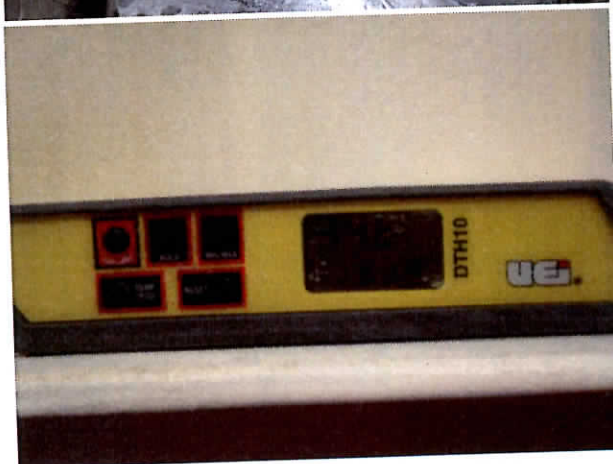
IDR Sheet		QA Key Personnel Function	Date
Sheet	4 of 4	Structural Inspector	Saturday, March 21, 2015
Inspector		IDR Report #	
Doug Brinius		3/21/2015 DB	
Inspector's Notes

TOP SIX: Top coat of Dura-plate 235, WFT reading, curing conditions after 3:00PM

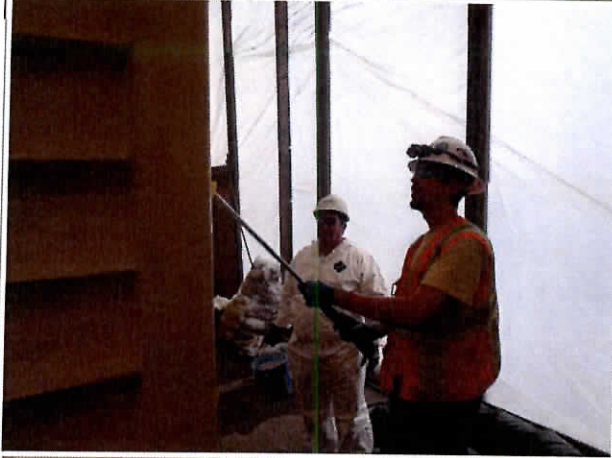
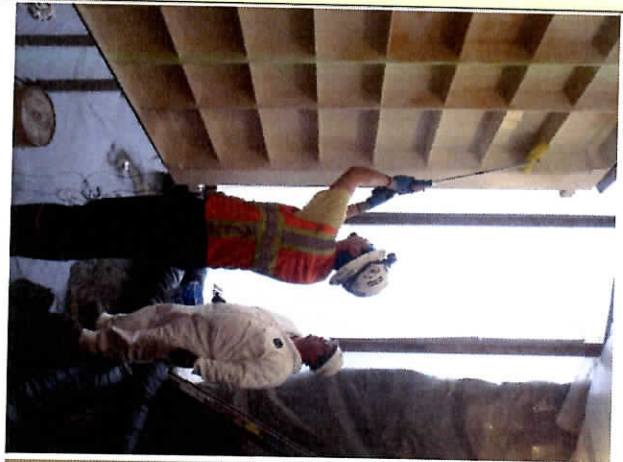
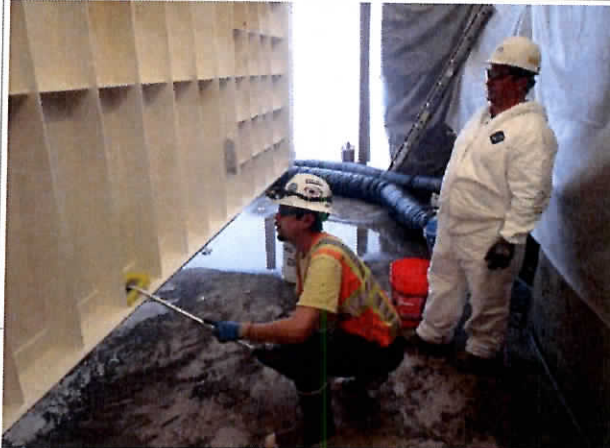
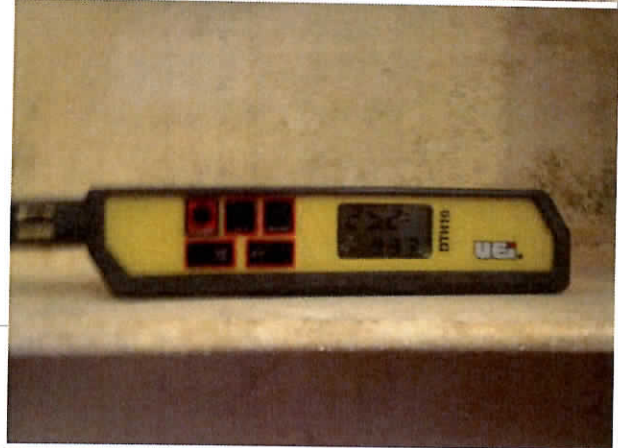
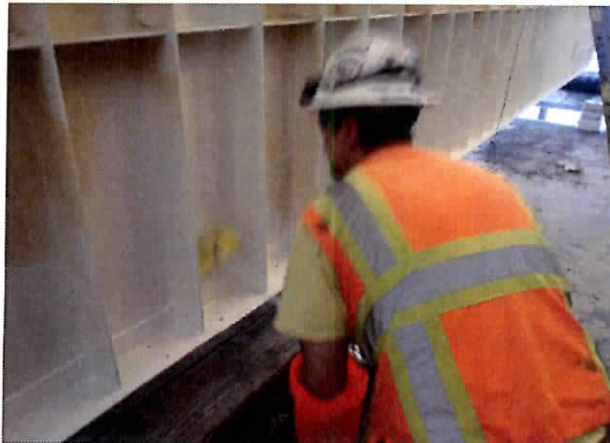
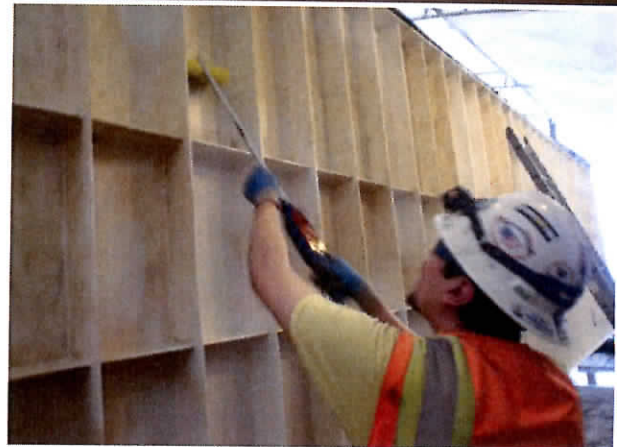
IDR Sheet Sheet 3 of 17	QA Key Personnel Function Structural Inspector	Date Monday, March 23, 2015
Inspector Doug Brinius	IDR Report # 3/23/2015 DB	
Inspector's Notes

TOP SIX: Truss 2/3 holiday testing, T2/T3 tent temperature readings

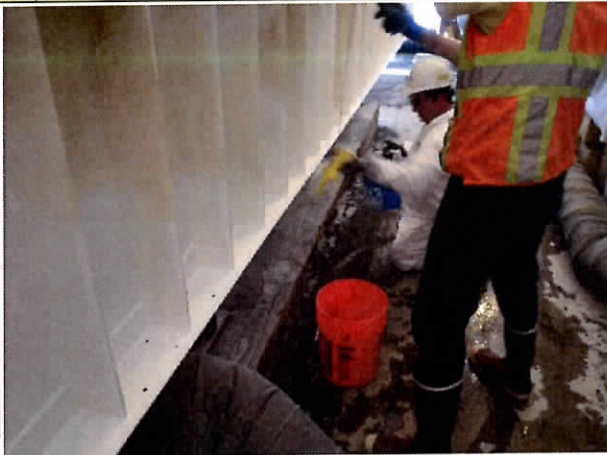
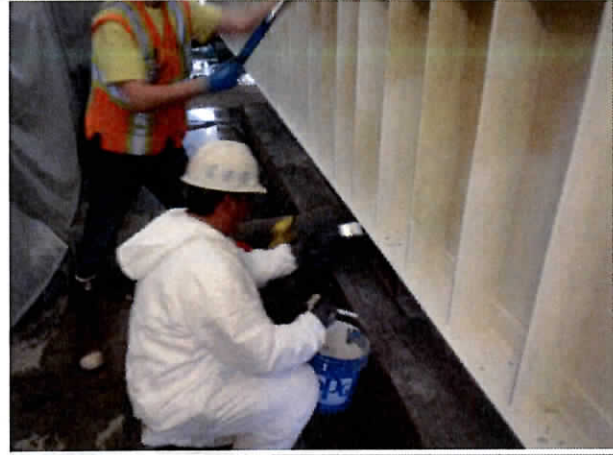
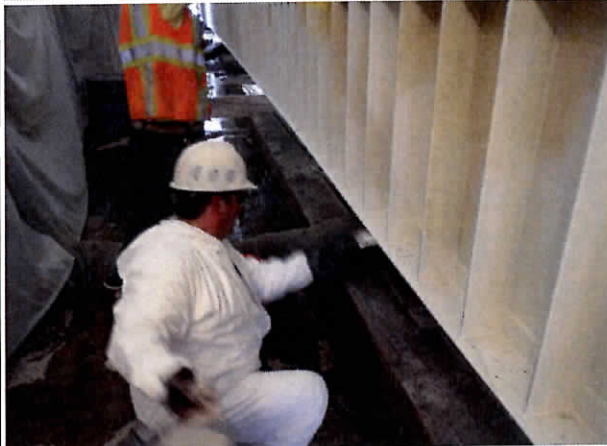
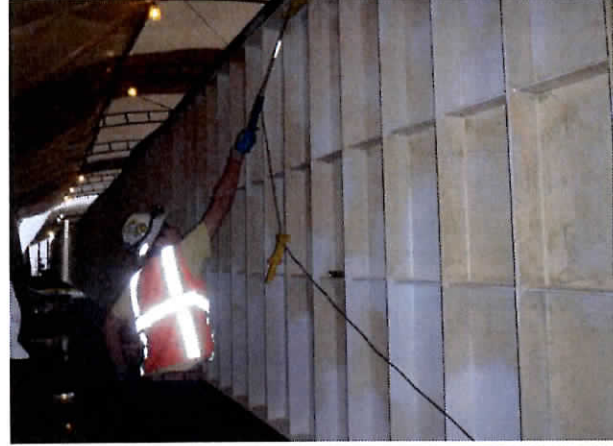
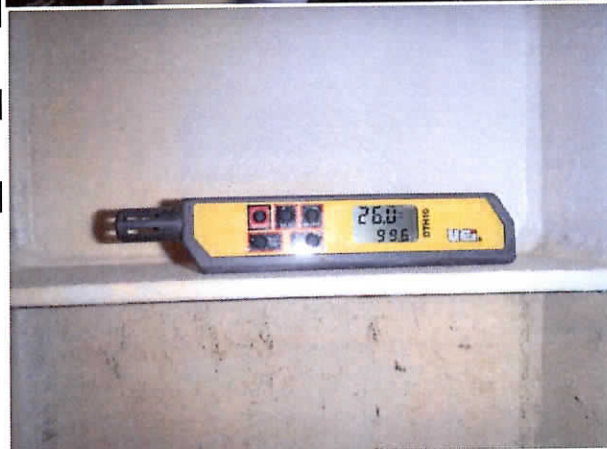
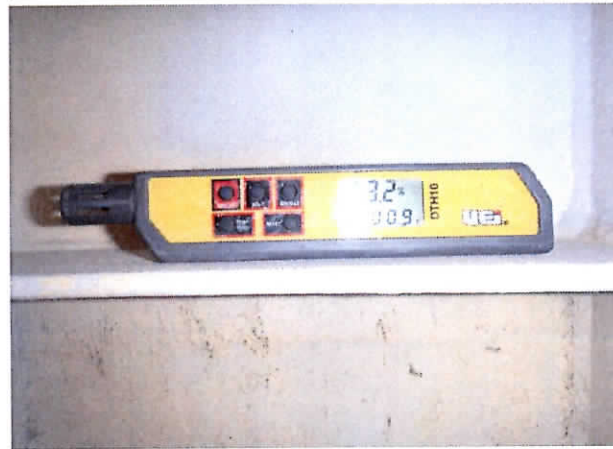
IDR Sheet	QA Key Personnel Function	Date
Sheet 4 of 17	Structural Inspector	Monday, March 23, 2015
Inspector Doug Brinius	IDR Report # 3/23/2015 DB	
Inspector's Notes

TOP SIX: Truss 2/3 holiday testing, T2/T3 tent temperature readings
